# Manhole Inspection Summary

Manhole # **S17C\_\_018MH**

Insp Date: **5/14/09 9:48 AM**

**Location** Address: **330 WARWICK AVE**

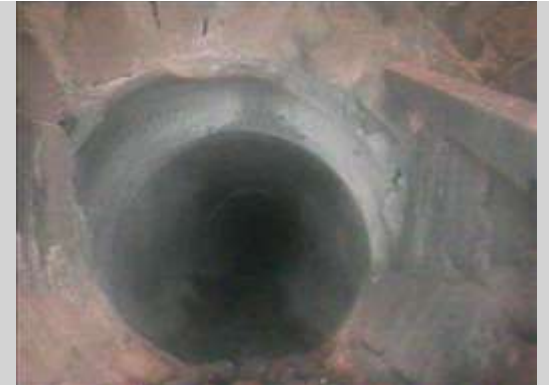
12 O'Clock Outflow

8 in. Circular Gravity Sewer  
Pipe Out @ 12 O'Clock

Pipe Material: **Clay** ☐ Pipe Lined

Invert Depth: **7.54** (ft.) Flow Characteristics: **None**

Infiltration: **None** Pipe Seal Cond: **Sound**

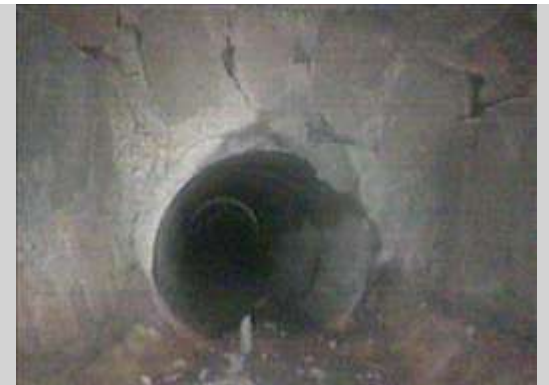
5 O'Clock Inflow

8 in. Circular Gravity Sewer  
Pipe In @ 5 O'Clock

Pipe Material: **Clay** ☐ Pipe Lined

Invert Depth: **7.49** (ft.) Flow Characteristics: **None**

Infiltration: **None** Pipe Seal Cond: **Cracked**

Connects To: **House connection / Service line**
